Condition Assessment

Site Name: Causeway Green Primary School – Photographic Record of Condition

23 May 2022

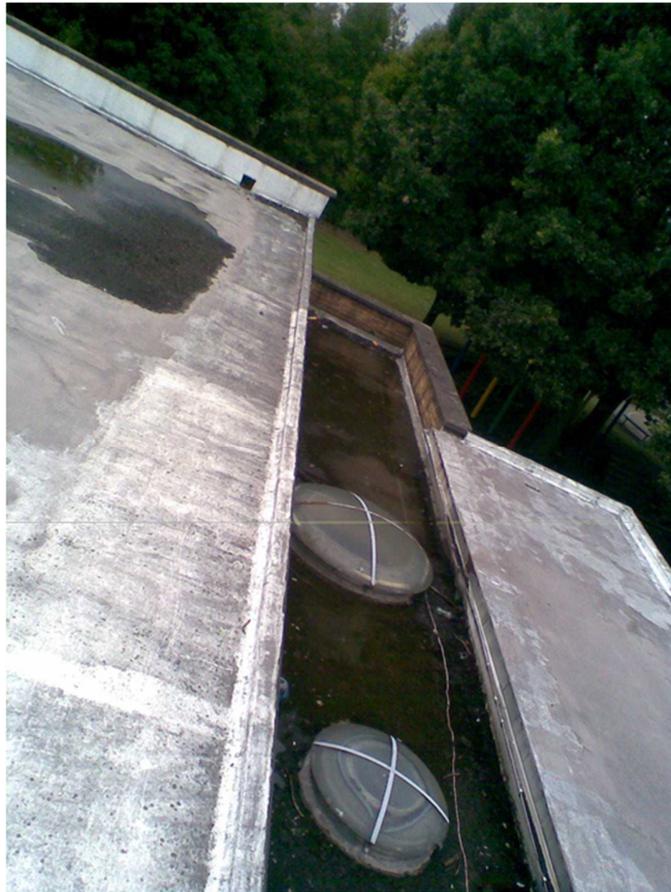
PLATE 1

- Locations 24 - 31
- Original asphalt roofs accounting for approximately 50% of total flat roof coverings;
- Solar reflective paint barely visible therefore roofs subject to high solar gain resulting in thermal shock;
- Poor application of solar paint resulting in fine alligator cracking of asphalt surface;
- Thermal shock results in significant deep cracking to asphalt allowing water ingress;
- Ponding present due to inadequate falls/historic settlement resulting in algal growth and accelerated deterioration of asphalt;
- Overlay single-ply membrane recommended within 2 years.

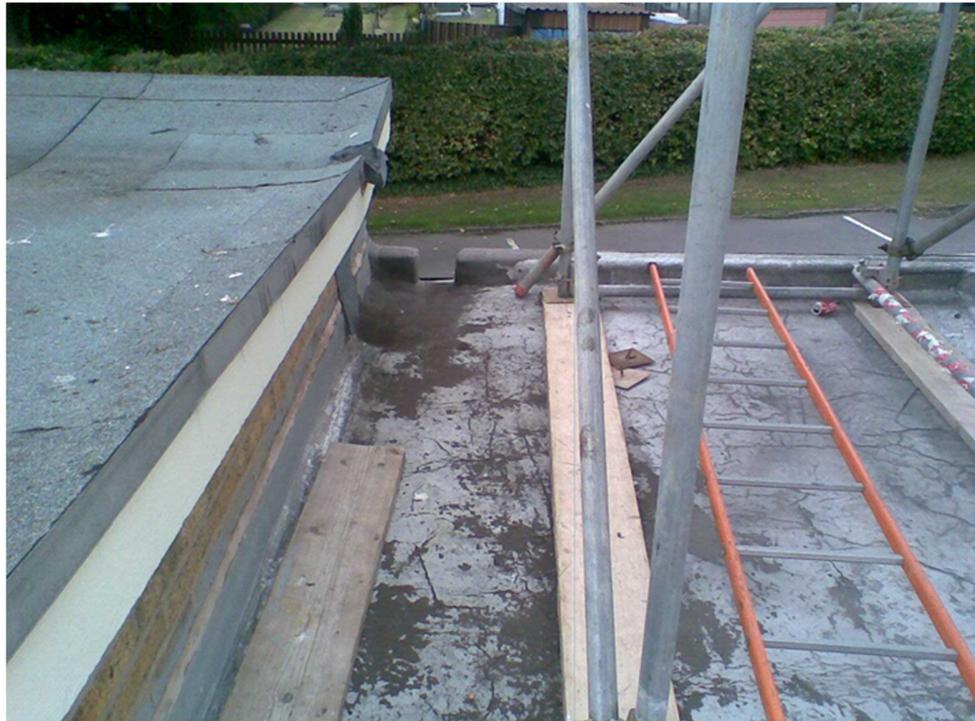
PLATE 2

- Locations B – H & 41 – 47; 40 & 94
- Asphalt roofs (inc. (49 - 96) with faded solar protection and significant alligator cracking;
- Felt roofs to (40), (94) and (68 - 84) in fair condition but likely 25 years old and well beyond life-expectancy of 15 years.
- Asphalt roofs require overlay within next 2 years, felt roofs within 5 years.

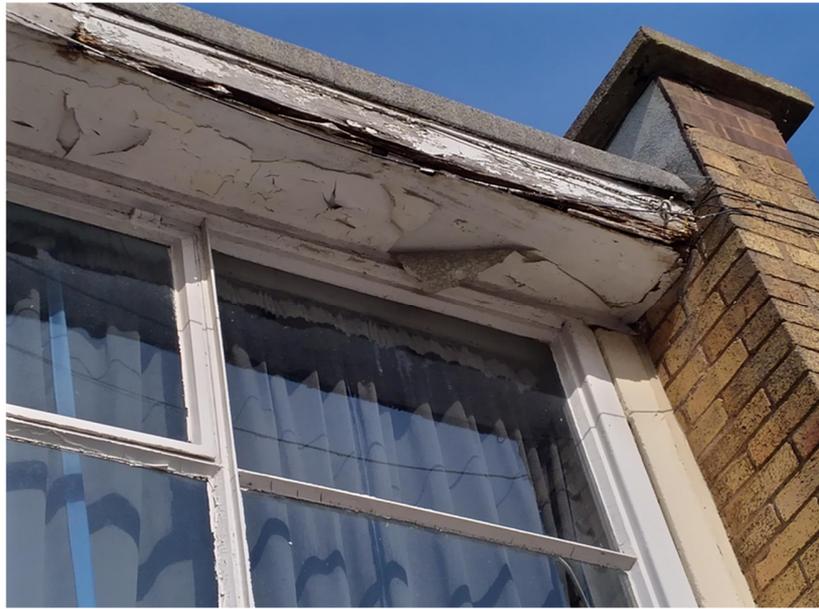
PLATE 3

- Timber fascias and soffits generally;
- Softwood fascias suffering moderate-to-severe decay requiring replacement or over-cladding;
- Soffits potentially ACM's generally in poor condition with badly flaking paintwork requiring removal and replacement if ACM or over-cladding if ply or cement-based. Complete redecoration.

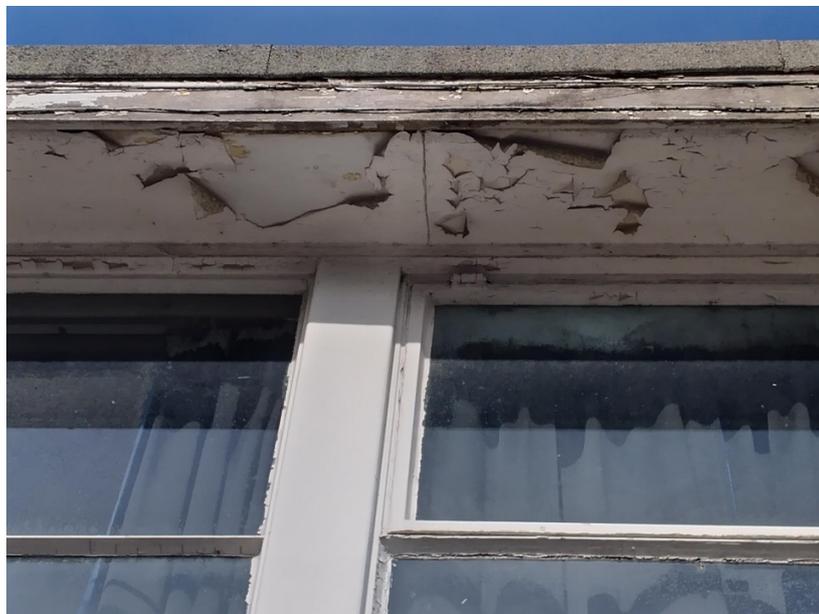
PLATE 4

- As Plate 3

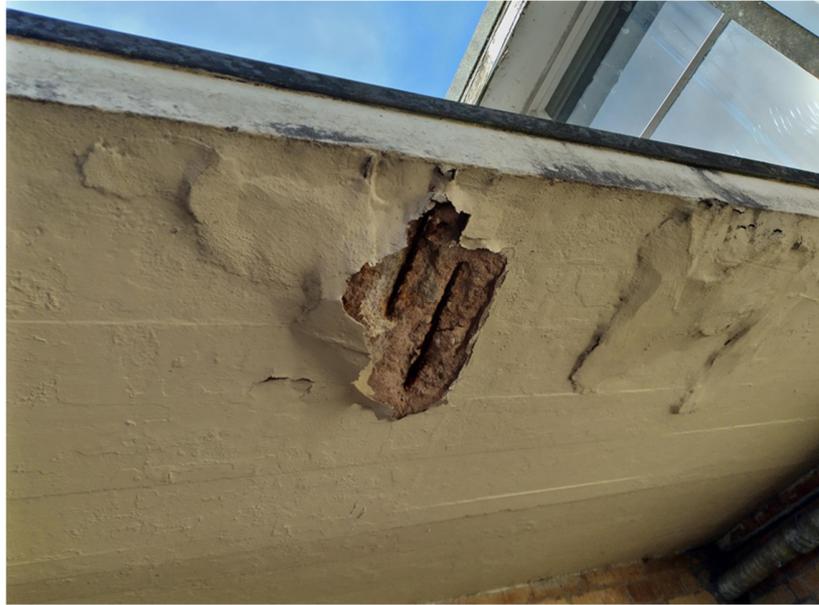
PLATE 5

- Pre-cast concrete soffits generally;
- Extensive spalling concrete due to inadequate cover depth and expansion of steel reinforcement due to rusting and caused by carbonation process;
- Remove all spalling sections, wire-brush loose rust, treat with inhibitor and make good with resin-based concrete prior to re-decoration.

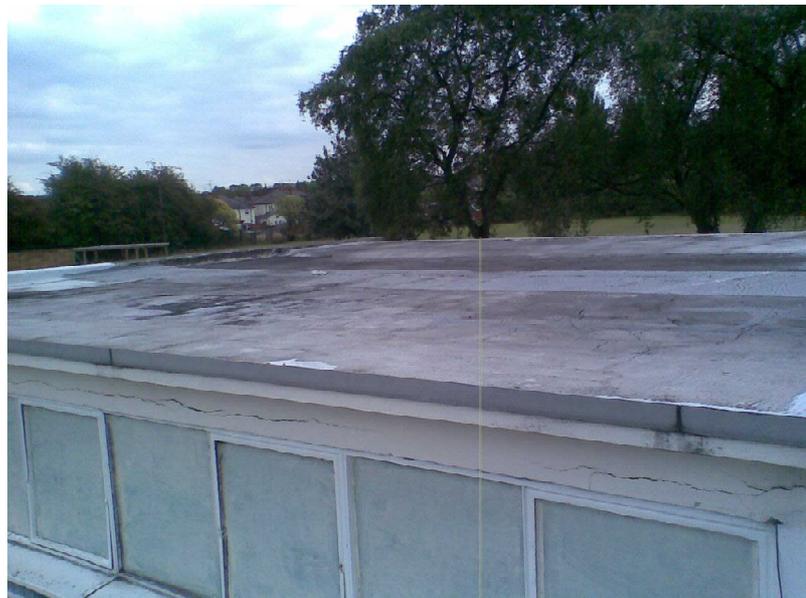
PLATE 6

- Location 18 & 23
- Excessive deflection to concrete frame beam with stress cracking to concrete;
- Install intermediate steel supports to reduce span & rake-and-fill cracks with resin-based compound.

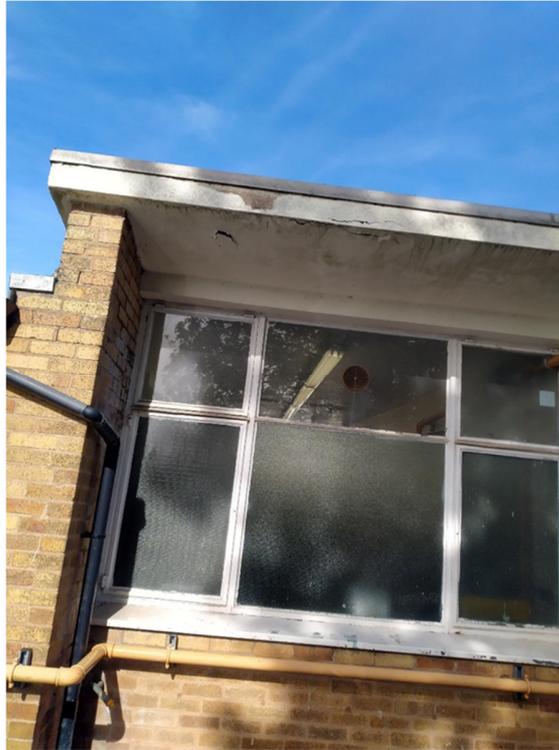
PLATE 7

- Location A (Kitchen)
- Spalling and exfoliating concrete to soffit caused by concrete carbonation, all as per Plate 5.

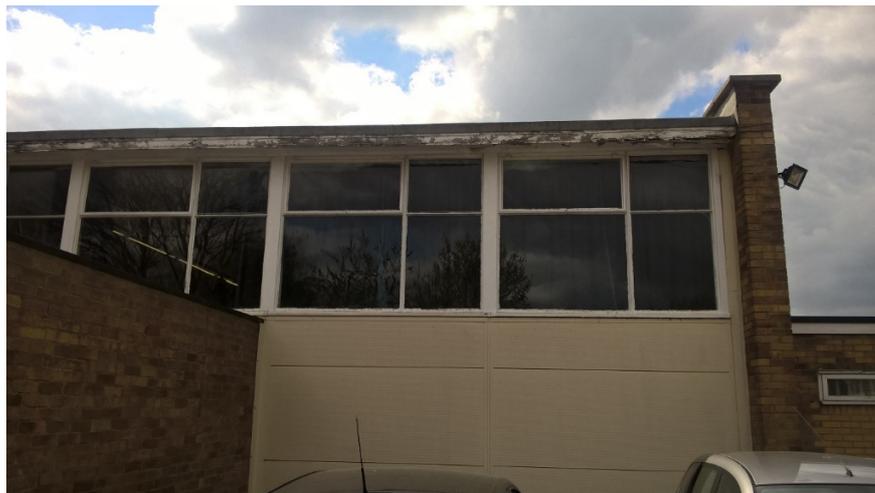
PLATE 8

- Location (94) Hall, (J) Dining Hall, (40) Gym & sundry locations
- Crittall metal framed windows, single glazed. Subject to solar gain in summer and high heat loss & condensation in winter. Opening casements prone to twisting & difficult to open & failing fasteners. Recommend phased replacement over next 5 years.

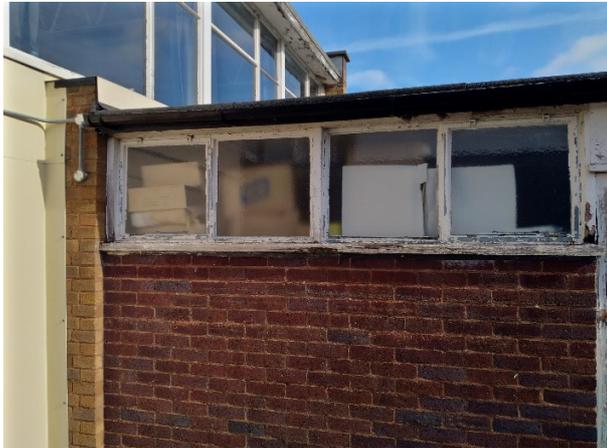
PLATE 9

- External Stores and secondary rooms around school;
- Metal frame window inserts in timber sub-frame. As Plate 8 windows subject to high heat loss & condensation issues. Recommend phased replacement over next 5 years.

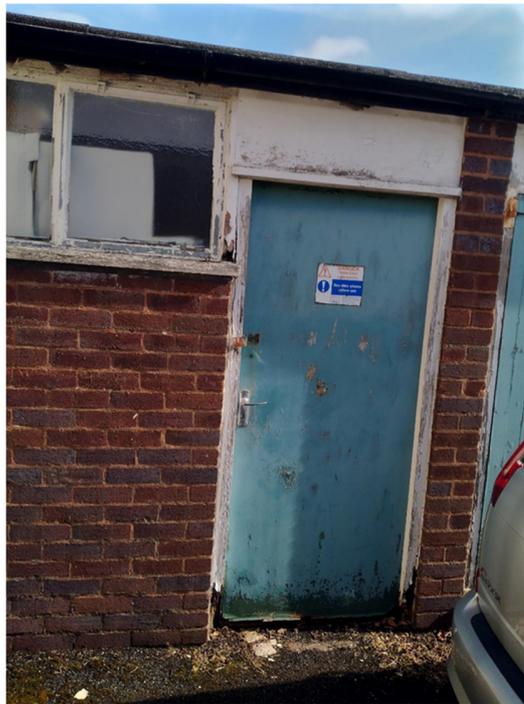
PLATE 10

- External Store
- Isolated timber doors & frame. Doors in poor condition and beyond economic repair. Recommend replacement with flush ply-faced doors in softwood frame within next 2 years.

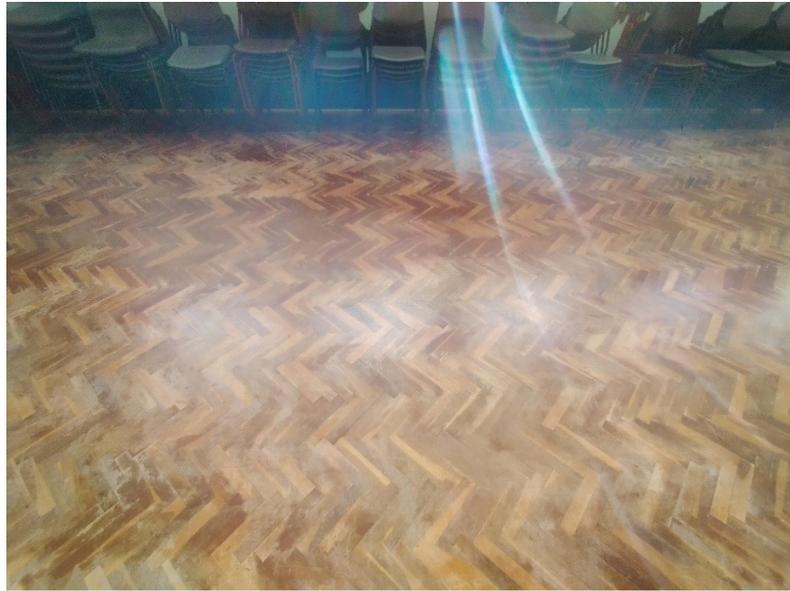
PLATE 11

- Location (94) – Replicated Locations (J) & (48)
- Original wood block floors set in herringbone pattern. Blocks badly worn and subject to previous sanding and varnishing regime. Consult flooring specialist for advice on whether renewal is necessary. Recommend refurbishment within 2 years.

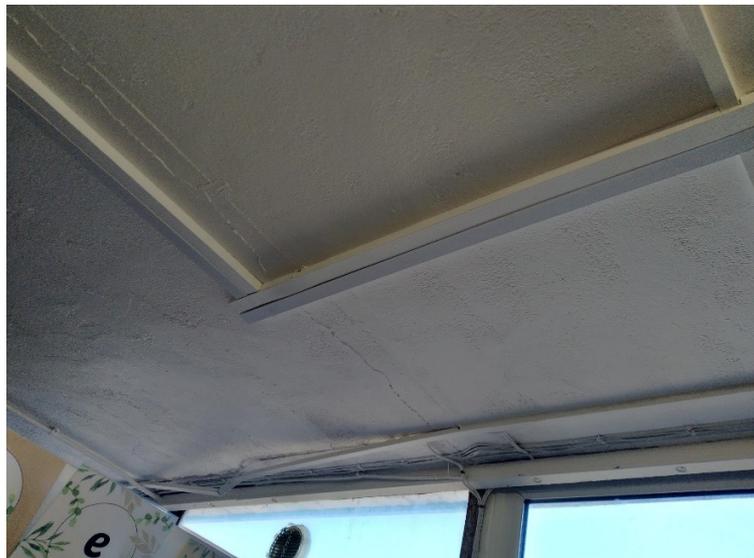
PLATE 12

- Infants Generally – concrete ceiling/roof structure.
- Concrete roofs to later Infant Block. Light cracking most likely due to shrinkage of concrete but deflection also possible. Plastic compound finish may contain ACM's so care must be taken with any remedial repairs. Dry-lining with insulated plasterboard preferred solution.

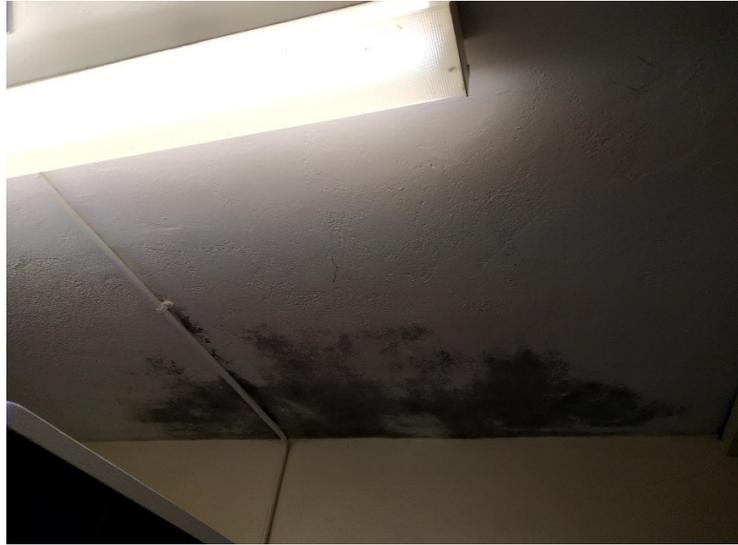
PLATE 13

- Various locations to Infant Block concrete roof/ceiling structure.
- Black mould predominantly at external wall junctions probably caused by condensation formed from cold-bridging with external wall resulting in mould growth on damp surfaces. Can be managed in the short-term by applying biocidal solution but improving insulation levels and ventilation is preferred method of managing black mould.

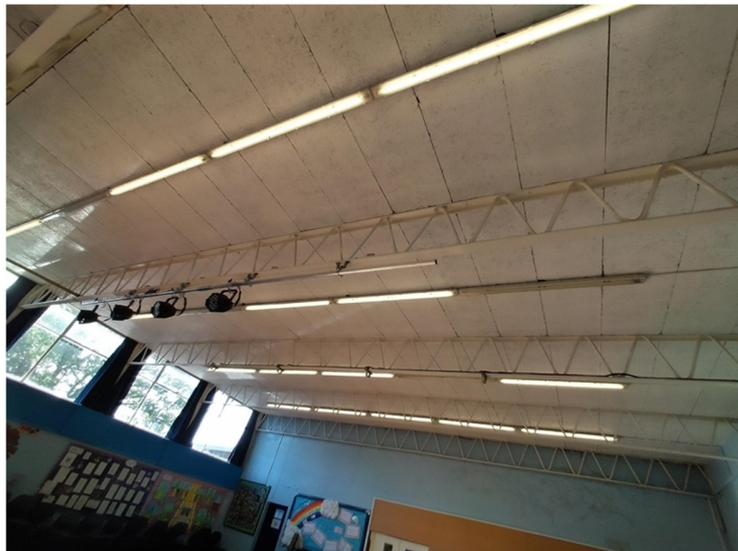
PLATE 14

- Ceiling/Roof construction to Junior Block and Halls & Gym;
- Consist of channel reinforced woodwool slabs spanning between steel lattice beams with painted self-finish and asphalt roof finish. Utilitarian in looks and subject to high heat-loss therefore recommendation is to underline with insulated suspended ceiling tile system with new LED lighting taking care to ensure void is ventilated to prevent condensation and black mould outbreak in void.
- Work recommended on phased basis over the next 5 years.

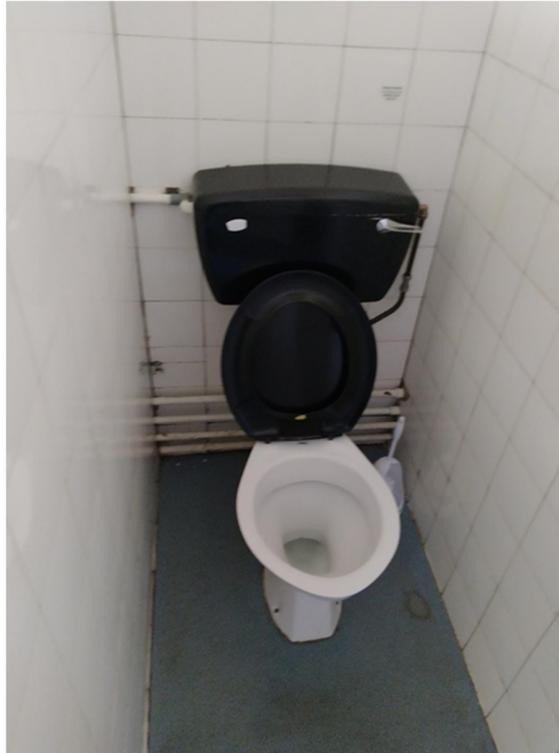
PLATE 15

- Staff Toilets
- Original sanitaryware and dated cubicle partitioning requiring refurbishment to modern standards.

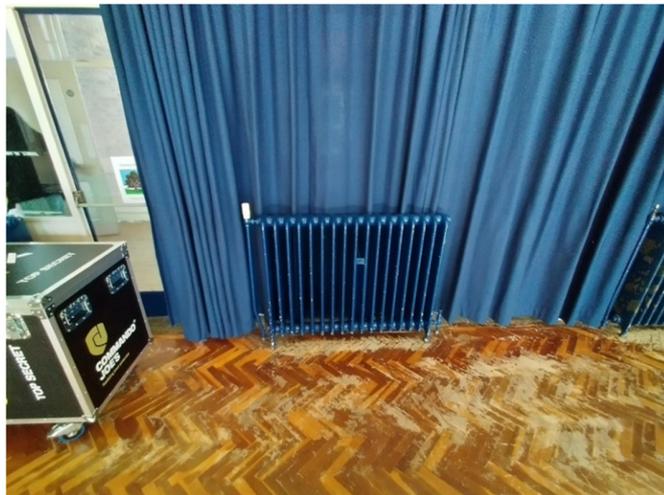
PLATE 16

- Original heat emitters & pipework.
- Boiler replaced circa 2016 but efficiency hampered by existing emitters and pipework. Pipework likely to suffer corrosion within floor voids so leakage anticipated long-term and ACM's may be present in the form of lagging. Advise phased replacement within 5-years.

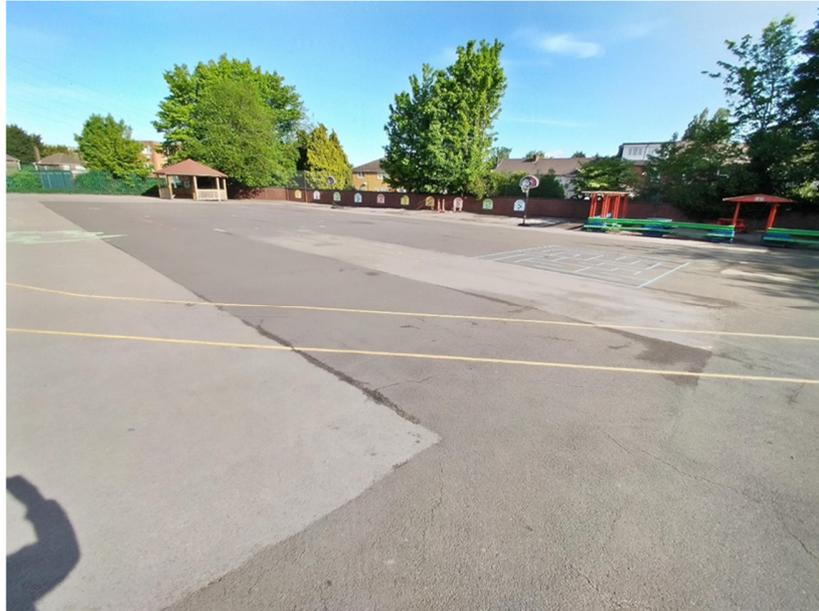
PLATE 17

- Junior main playground;
- Tarmacadam in advanced stage of deterioration with extensive alligator cracking and fretting surface. Re-surfacing recommended within 12 months to avoid more expensive reconstruction work.

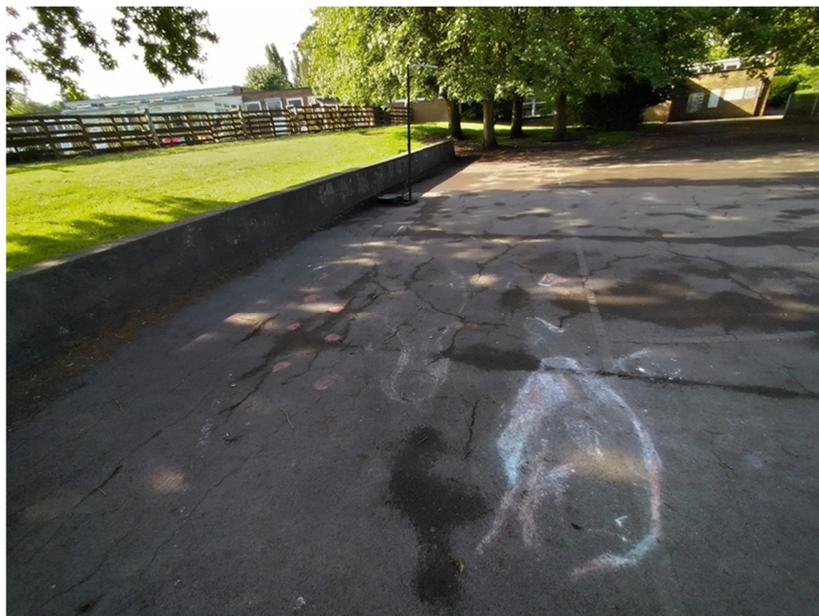
PLATE 18

- Junior rear playground;
- Tarmacadam in very poor condition with extensive cracking and breaking-up of surface, As with main playground resurfacing urgently required to prevent more expensive reconstruction work.

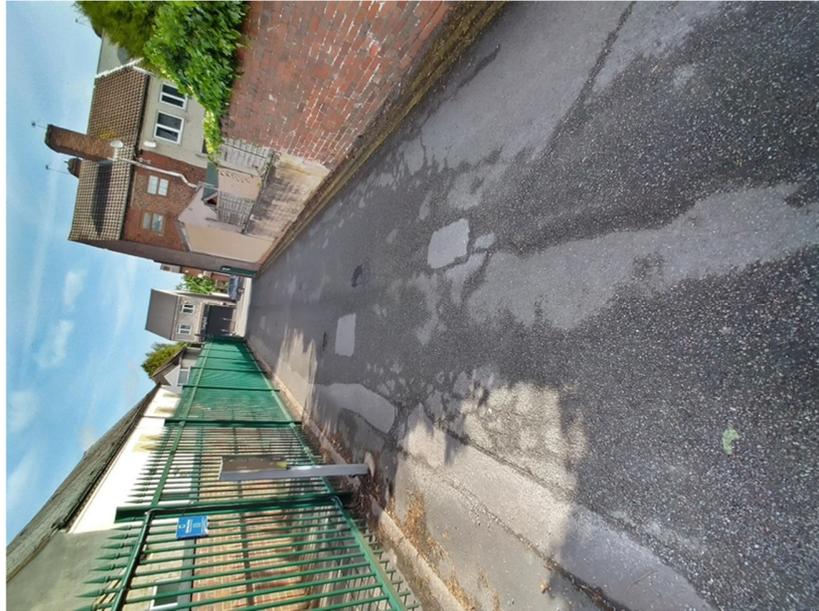
PLATE 19

- Main entrance tarmacadam driveway;
- Road surface in poor condition with extensive cracking and breaking-up of surface. As with playgrounds re-surfacing required in near future to prevent more expensive reconstruction work.

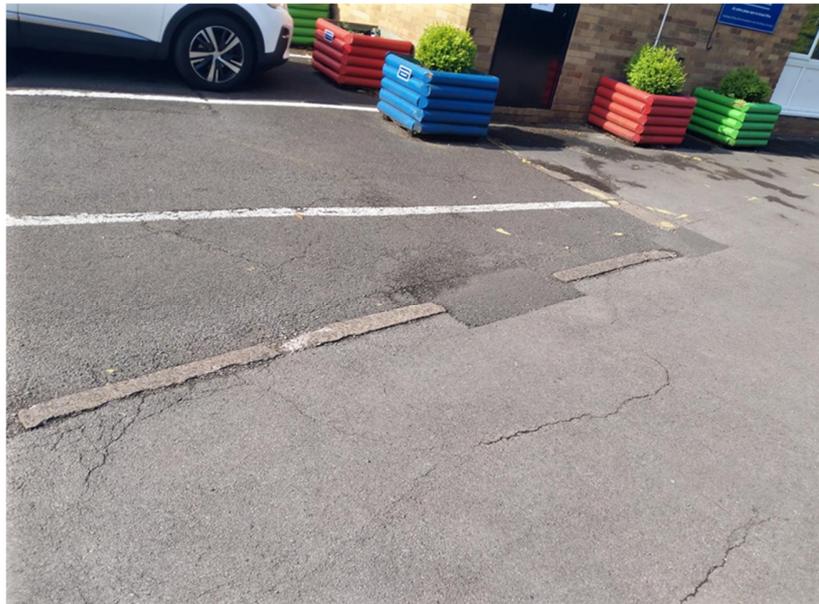
PLATE 20

- Tarmacadam car park;
- As Plate 19 comment.

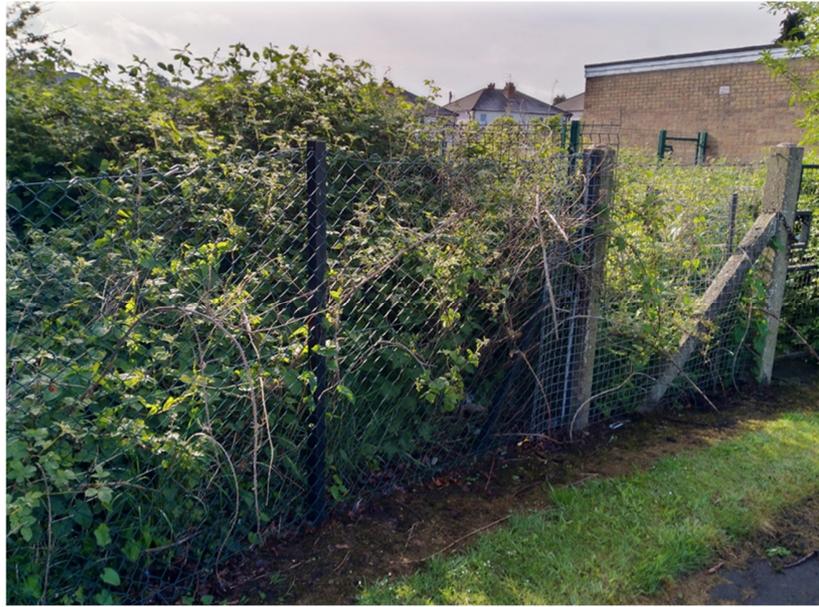
PLATE 21

- Boundary Fencing;
- Plastic-coated chain-link fencing on metal posts and paneled fencing backing on to houses. Failing low-security fencing with broken straining wire and buckled panels. Fencing where necessary to be replaced to meet safeguarding concerns. Masonry boundary walls require minor repair and re-pointing.

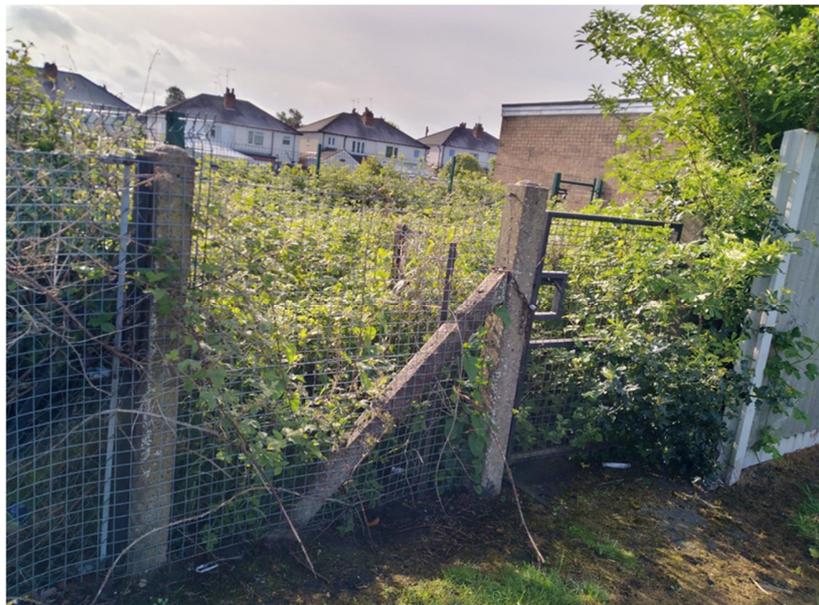
PLATE 22

- Boundary Fencing;
- As Plate 21. Any safeguarding weaknesses to be addressed within 12 months.

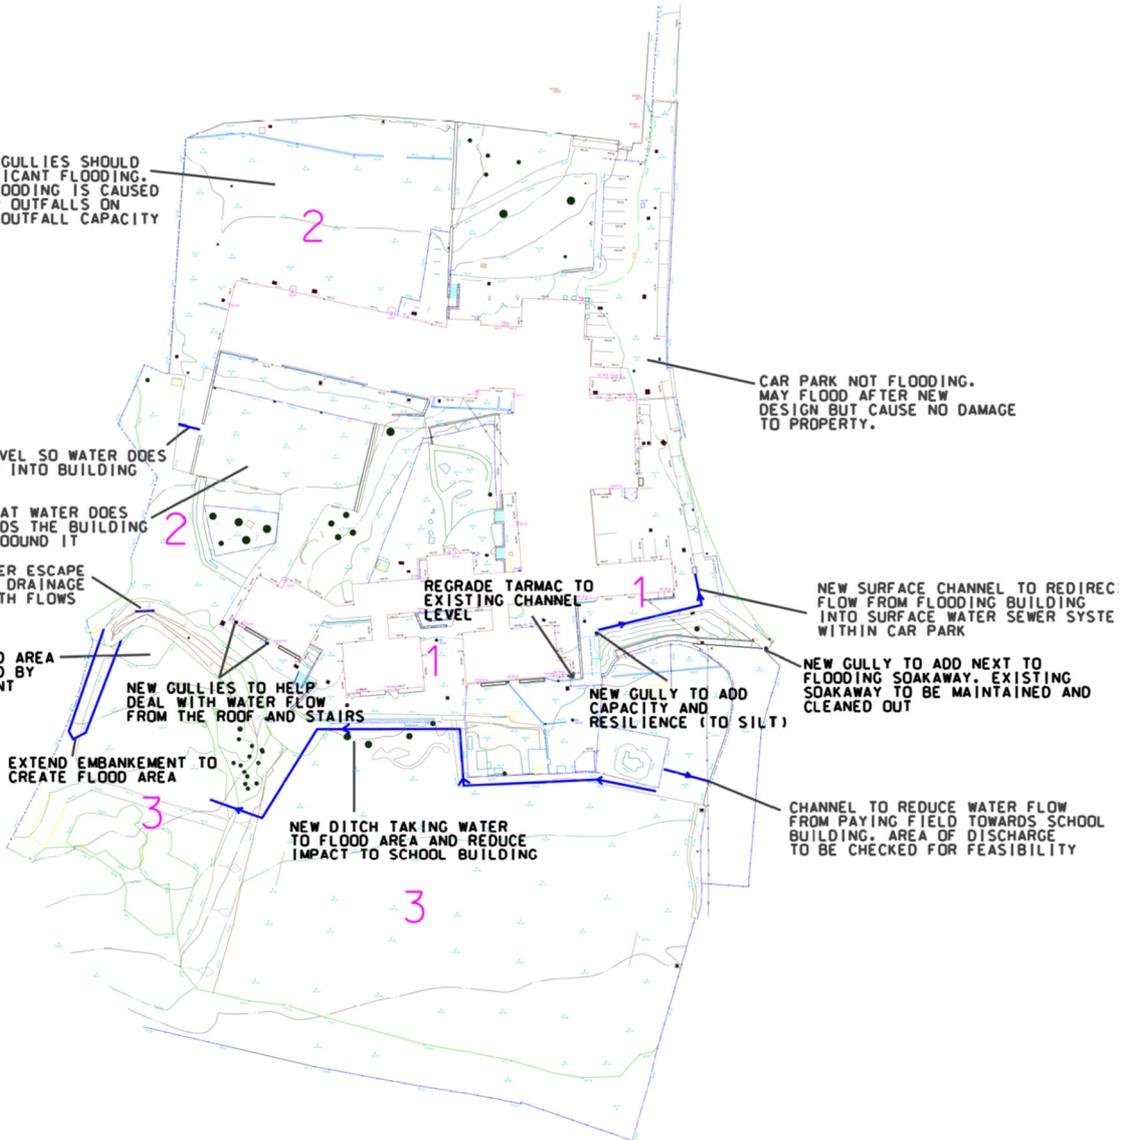
CAUSEWAY GREEN PRIMARY ● PROPOSED FLOOD ALLEVIATION SCHEME

PLAYGROUND GULLIES SHOULD STOP SIGNIFICANT FLOODING. CHECK IF FLOODING IS CAUSED BY IMPROPER OUTFALLS ON GULLIES OR OUTFALL CAPACITY

CAR PARK NOT FLOODING. MAY FLOOD AFTER NEW DESIGN BUT CAUSE NO DAMAGE TO PROPERTY.

FIX LEVEL SO WATER DOES NOT GO INTO BUILDING

PENSTOCK TO LET WATER ESCAPE FLOOD AREA ONCE THE DRAINAGE SYSTEM IS COPING WITH FLOWS

NEW FLOOD AREA CONTAINED BY EMBANKMENT

EXTEND EMBANKMENT TO CREATE FLOOD AREA

NEW GULLIES TO HELP DEAL WITH WATER FLOW FROM THE ROOF AND STAIRS

NEW DITCH TAKING WATER TO FLOOD AREA AND REDUCE IMPACT TO SCHOOL BUILDING

REGRADE TARMAC TO EXISTING CHANNEL LEVEL

NEW GULLY TO ADD CAPACITY AND RESILIENCE (TO SILT)

NEW SURFACE CHANNEL TO REDIRECT FLOW FROM FLOODING BUILDING INTO SURFACE WATER SEWER SYSTEM WITHIN CAR PARK

NEW GULLY TO ADD NEXT TO FLOODING SOAKAWAY. EXISTING SOAKAWAY TO BE MAINTAINED AND CLEANED OUT

CHANNEL TO REDUCE WATER FLOW FROM PAYING FIELD TOWARDS SCHOOL BUILDING. AREA OF DISCHARGE TO BE CHECKED FOR FEASIBILITY
