Brandhall Flood Investigation Report

Sandwell Metropolitan Borough Council

Project reference: Brandhall Urban Village
Project number: 60653817

05 May 2022

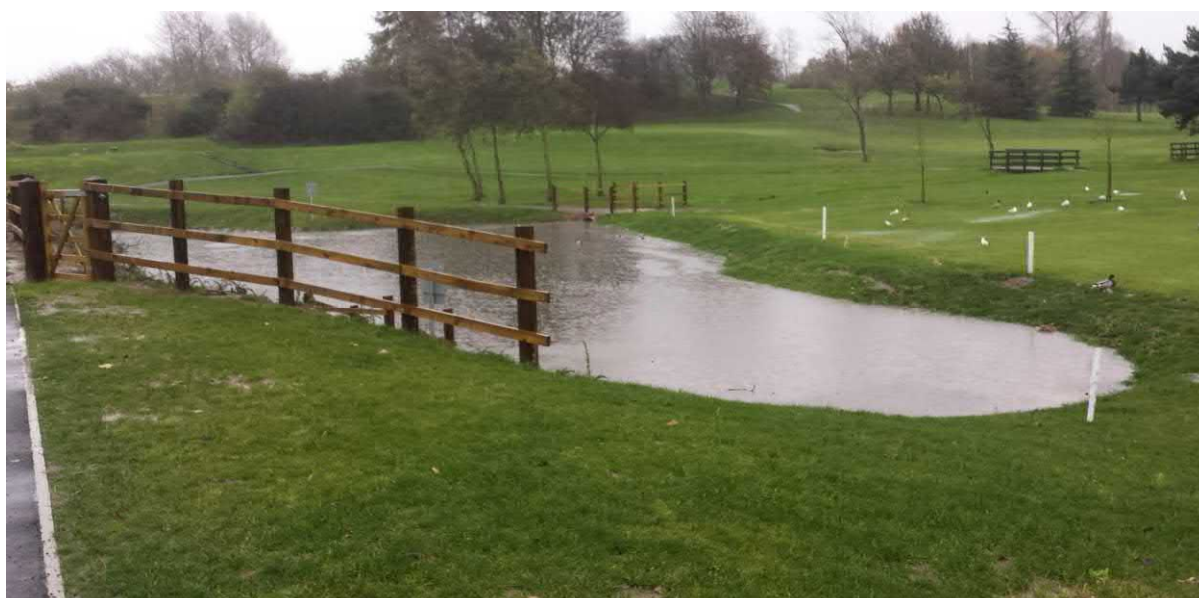
Figure 11: Existing Flood Storage Area nearing Capacity (November 2014)

Location	Source	Date	Description
Along northern Site boundary adjacent to the Wolverhampton Road tributary	SMBC (anecdotal)	Prior to 2015 (exact date(s) unknown)	Reported flood events at properties along the northern Site boundary adjacent to the Wolverhampton Road tributary. Works to improve stability and provide scour protection along the tributary was undertaken (the consent application is dated August 2015). SMBC are not aware of flooding issues since.
Within golf course Site and around existing Flood Storage Area	SMBC (email from Sandwell Leisure Trust who formerly managed the golf course Site prior to its closure)	Late 2014 (exact date(s) unknown)	<p>Areas of ponding within the golf course.</p> <p>Concerns that the existing FSA is nearing capacity (Figure 11), although there have been no reports of the FSA overtopping.</p> <p>Maintenance difficulties with the headwall of the FSA causing water to back up into the storage area.</p> <p>Works were undertaken to the trash screen of the outlet of the existing FSA to improve maintenance accessibility, and to the drainage system within the golf course.</p>

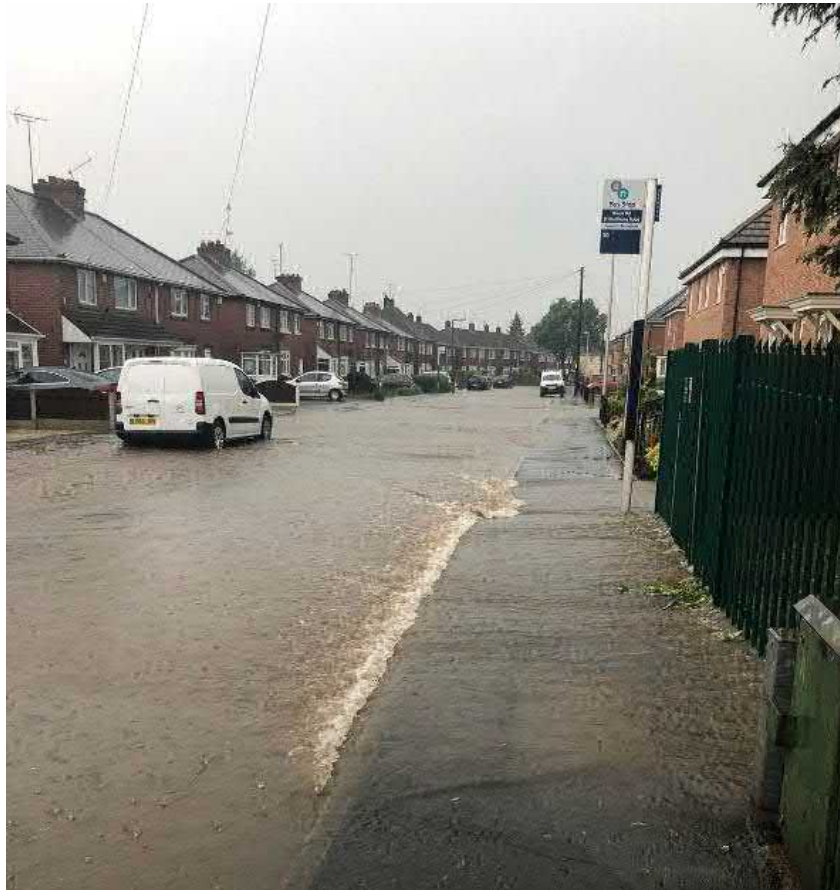
Figure 12: Photograph of Flooding on Brook Road

Location	Source	Date	Description
Brook Road residential gardens and driveways.	Public consultation responses	Around 2016 (exact date(s) unknown)	<p>A photograph provided by a resident (Figure 12) indicates that water overtopped where Brandhall Brook flows into the culvert beneath Brook Road.</p> <p>The photograph suggests relatively fast moving water on Brook Road and a depth of flooding of approximately 50mm.</p> <p>Sandbags were deployed by SMBC to a property on Brook Road in this location.</p>

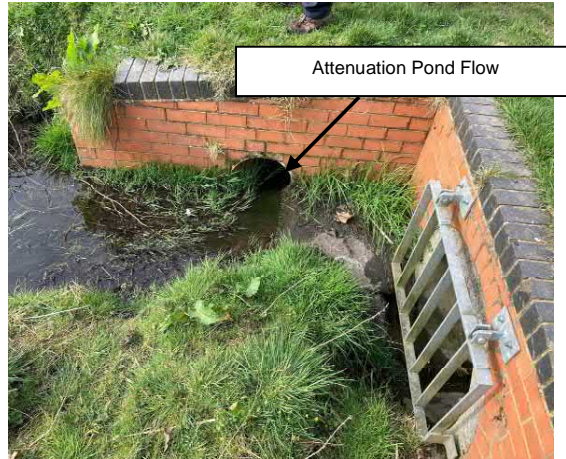
Figure 13: Site Visit Photograph - Vegetation overgrowth

- Further upstream along the Brandhall Brook, it is culverted beneath a raised path. The pipe appeared blocked with water accumulating upstream.
- The Brandhall Brook within the golf course Site is generally poorly maintained with areas containing significant siltation and vegetation overgrowth. In one location (Figure 13 overleaf) this has caused flows from the Brandhall Brook being preferentially diverted into the offline attenuation pond rather than continuing along the culverted reach of the Brandhall Brook

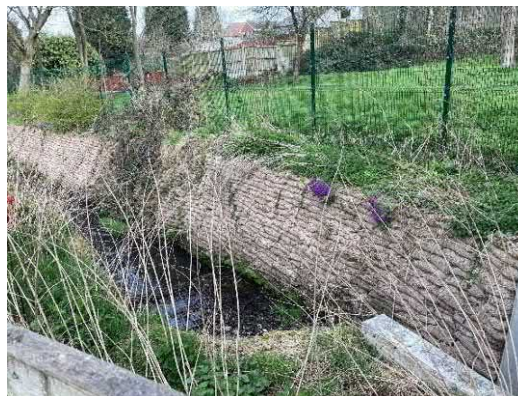
Figure 15: Site Visit Photograph - Wolverhampton Road tributary

- Scour protection has recently been installed on the Wolverhampton Road tributary to promote in-channel stability (Figure 15 overleaf). Prior to the repair scheme, the channel banks had partially collapsed, obstructing flow. During the site visit the channel appeared well maintained.

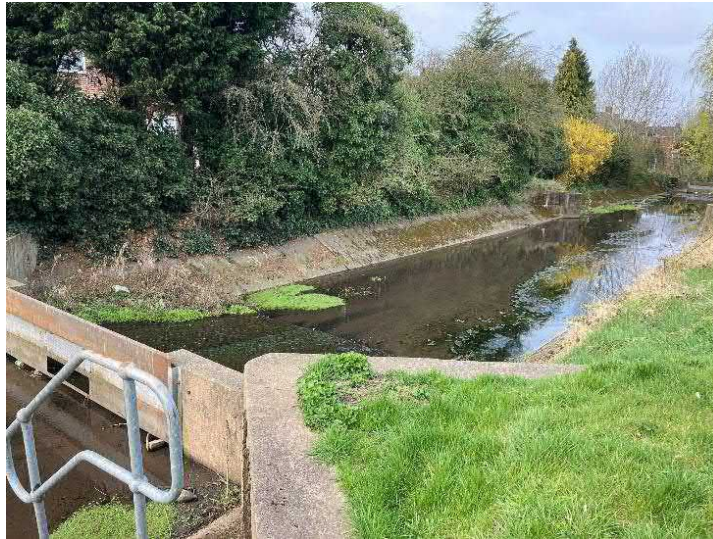
Figure 16: Site Visit Photograph - Brandhall Brook parallel to Brook Road

- The Brandhall Brook to the north of the golf course is a wide, heavily modified concrete channel (Figure 16). It contains several structures which appear to maintain upstream water levels.
- The inlet to the culvert beneath Brook Road is protected by a double trash screen which is fenced off from public access (Figure 17). The trash screen is an EA asset.
- In general, there appears to be a significant amount of storage volume available both within the golf course Site and in the Brandhall Brook channel downstream.

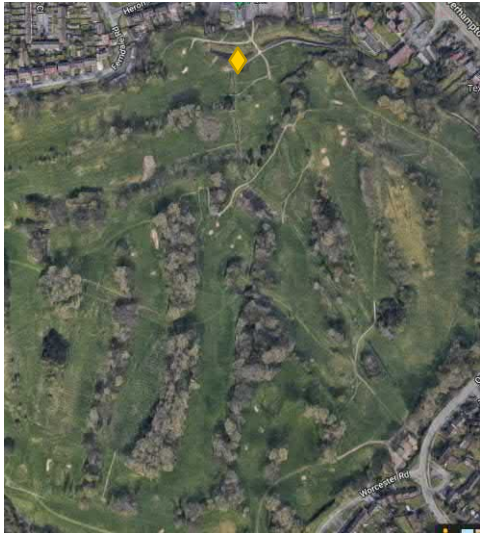
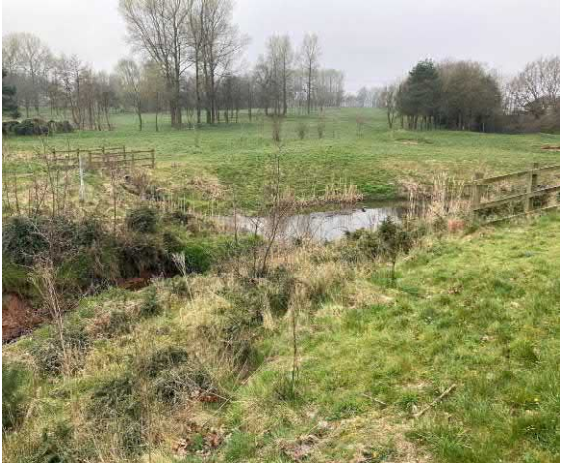
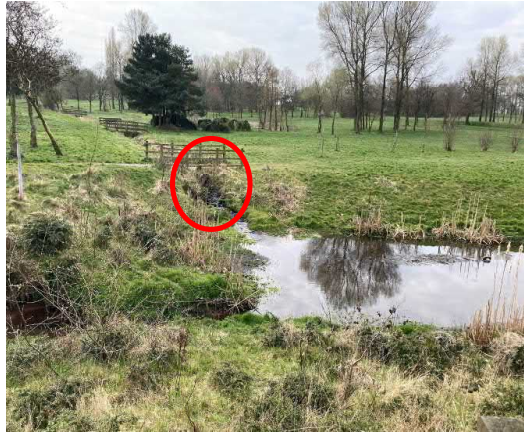
<p><u>North of Brandhall Golf Course, existing Flood Storage Area (FSA)</u></p> <p>Kevin mentioned that he has seen the pond approximately half-way full however, has not been on site following a significant storm. This is concurrent with approximately invert level of the outlet culvert ($\varnothing \sim 750\text{mm}$) into the main channel (highlighted by red circle).</p>

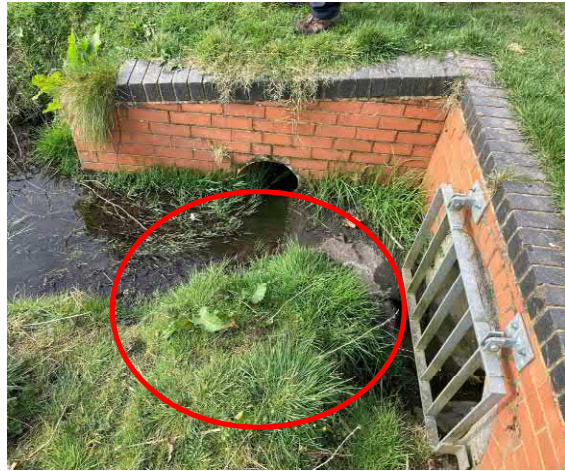
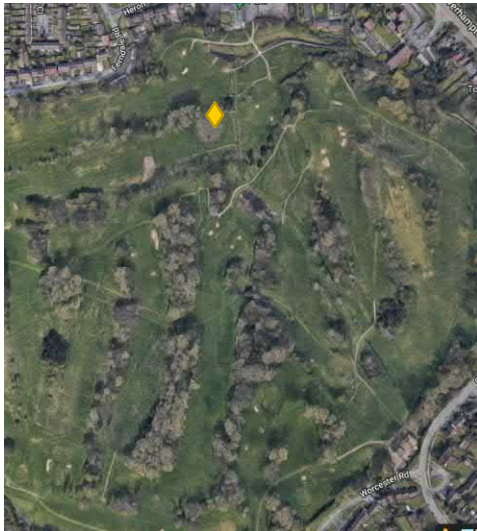
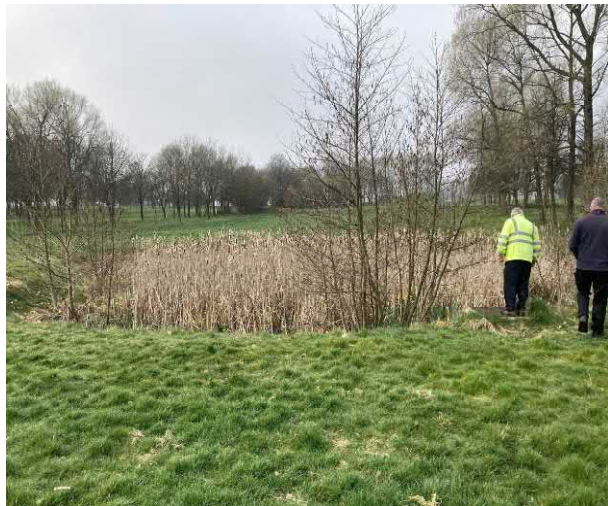
Culverted section of watercourse with what appears to be an offline attenuation pond. Entrance to culvert was partly silted up which meant that water was preferentially flowing into the attenuation pond in the first instance.

Offline attenuation pond to west

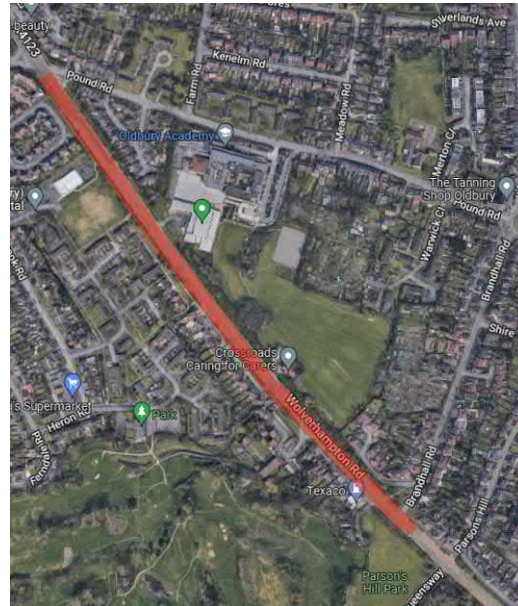
Only 7 road gullies from Pound Road to this junction (approximately 800m length, highlighted in red).

Junction is a low point in Wolverhampton Road. There's a lack of highway gullies. Uncertain of whether the drainage connects into the water course on the golf course site.

In order to provide evidence to support the likely cause of flooding outlined above, a CCTV survey should be undertaken to confirm where the highway drainage in this location discharges into and to understand the existing capacity of the highway drainage.
