Sandwell Metropolitan Borough Council

Action Taken Under Delegated Powers

Demolition of Garages at Cumberland Road, Oldbury, B68 0AL

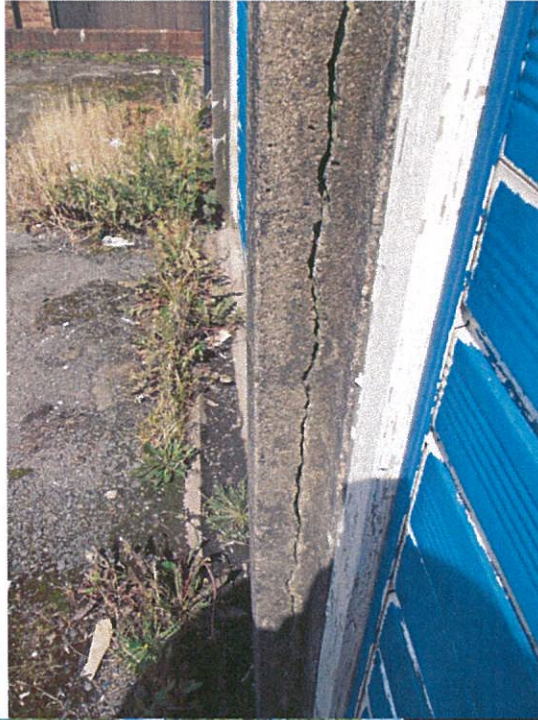
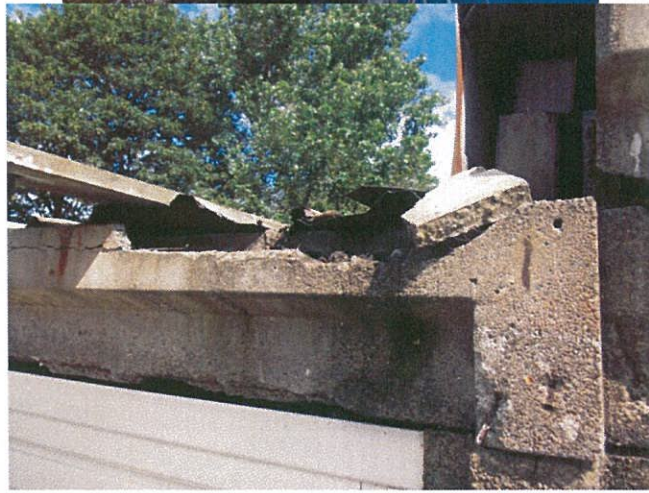
Photographs of the Garages at Cumberland Road, Oldbury B68 0AL

- 3.1 At the end of Cumberland Road, Oldbury there are a row of eight Council Owned Garages that are constructed from Precast Concrete frames with brickwork end panels and blockwork internal walls. The condition of these garages is very poor with the concrete frames cracking and moving leading to the separation of the blockwork walls. All timber fascias are rotten and the roof, comprising of a corrugated steel panels, is rusting and damaged in places.

- 3.6 The general very poor condition of the garages is highlighted by photographs included in Appendix 1.
- 3.7 The location of garage block is included in the site plan at Appendix 2.
- 3.8 The Council has a demolition framework managed by Urban Design and Building Services which will be used to hold a mini competition for the delivery of the works.

- 2.1 To progress with the demolition of the block of garages at Cumberland Road, Oldbury B68 0AL and to make good surfaces affected to create additional parking.

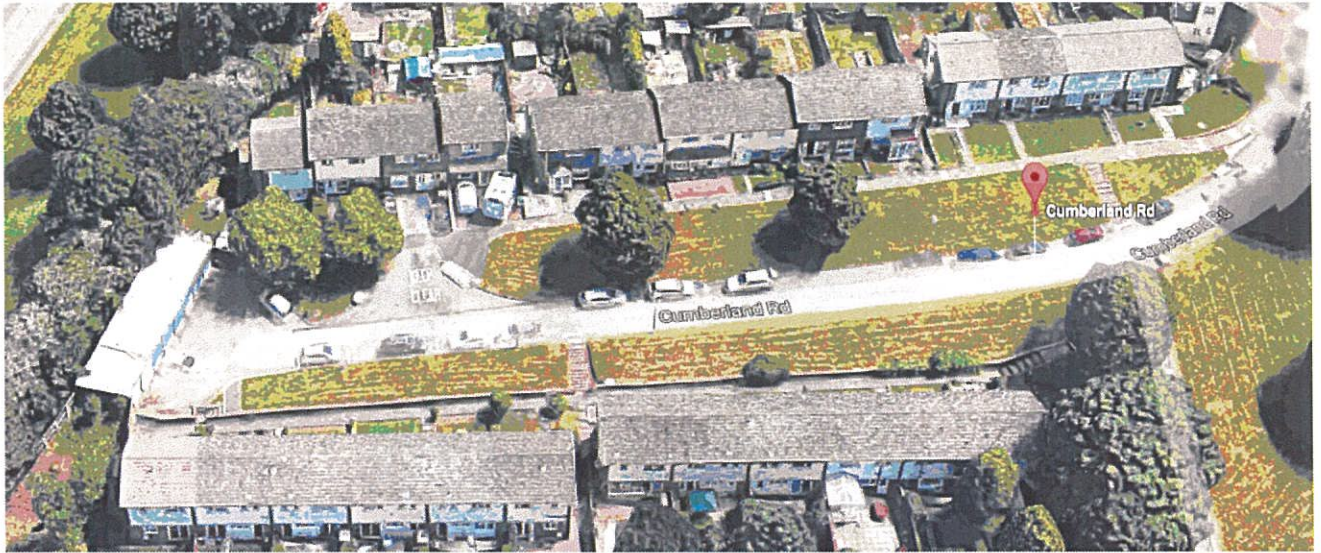
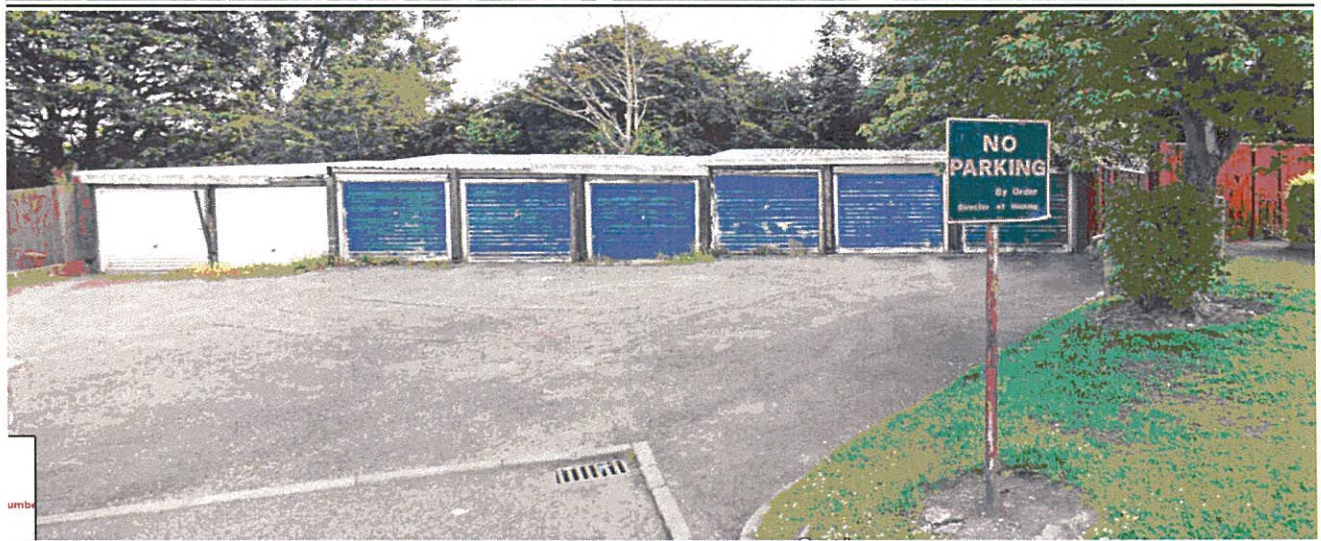
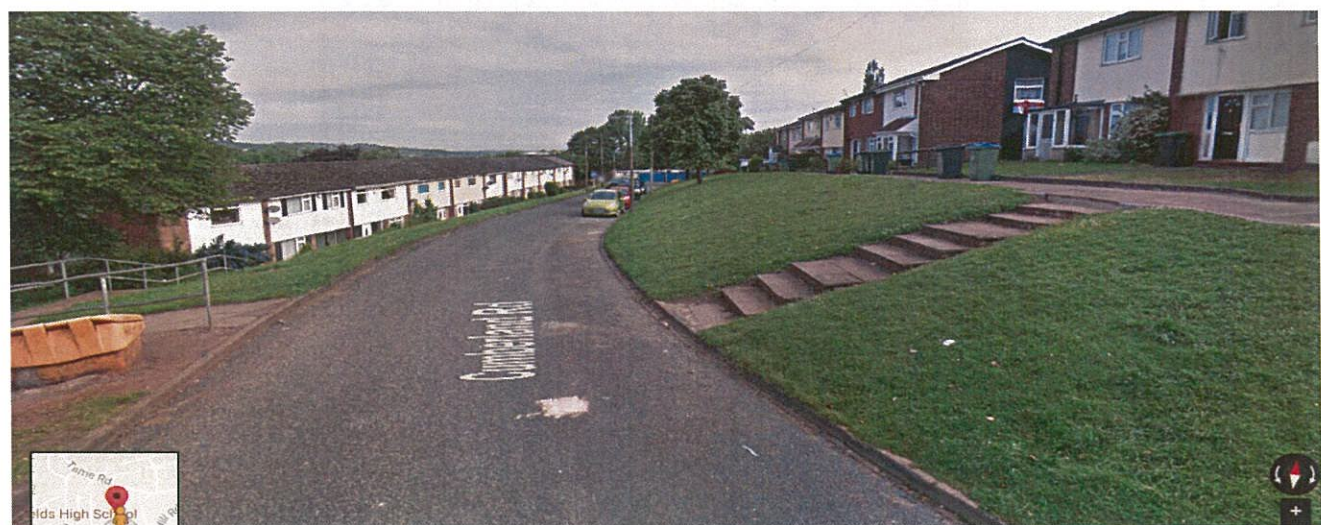
Appendix 2 – Photographs of the Site Plan

- 3.2 The condition of the garages means that they are beyond economical repair.
- 3.3 Cumberland Road is a long, narrow road which is also heavily inclined (see appendix 2, photo 3), making off street parking on property frontages extremely problematic and in many instances, impossible. This issue is compounded by the narrow street which is easily blocked by parked vehicles, forcing residents to park in the turning circle and often obstructively on the garage forecourt. This is creating discontent from paying garage tenants.
